LINTON VILLAGE, NEAR WETHERBY,
WEST YORKSHIRE

HIGHWAY ASSESSMENT

12070 / November 2012

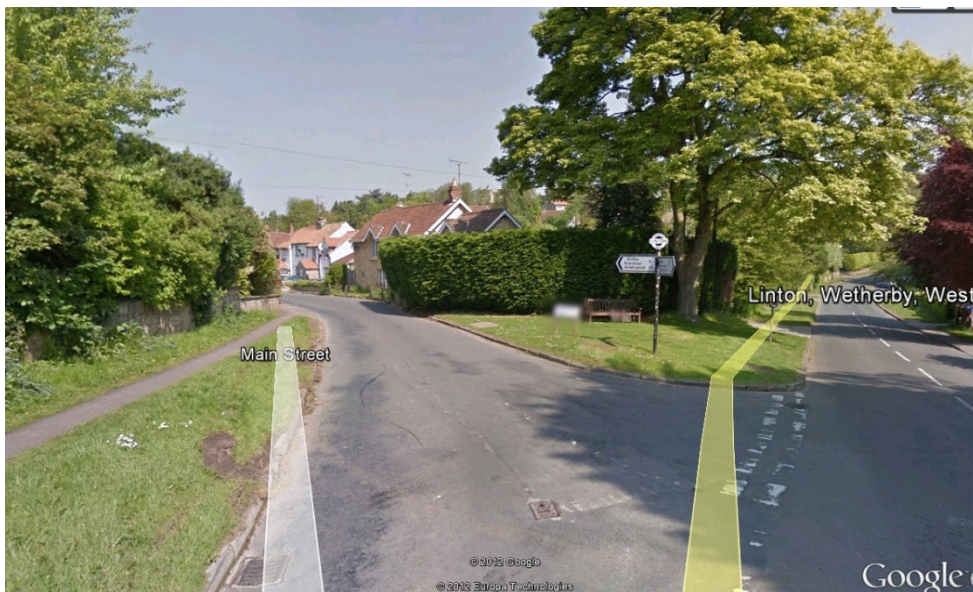
2.2.14 The angle of Northgate Lane relative to Main Street is such that the corner radius leading from the latter in to the former is quite generous resulting in higher than necessary speeds of turning vehicles. This coupled with the embankment on the western side of Main Street reduces the forward visibility of the width restriction (mentioned below) and of any vehicle passing through it.

2.2.15 In addition Northgate Lane narrows to 4.5m close to the junction forming a constraint on movement of traffic although no problems were observed on our site visits with the exception of the higher approach speeds from Main Street due to the generous corner radius. The photograph below illustrates this point.

Northgate Lane junction with Main Street – corner radius and narrowing

3.2.2 The pinch points identified on Northgate Lane do not appear to cause any operational difficulties and are natural calming features. However the one close to the junction with Main Street is affected by the higher approach speeds from Main Street due to the generous corner radius. In addition the section of Northgate Lane close to its junction with Sicklinghall Road is a cause for concern and will only deteriorate further as more vehicles over run the verge and the edge of carriageway frets away.

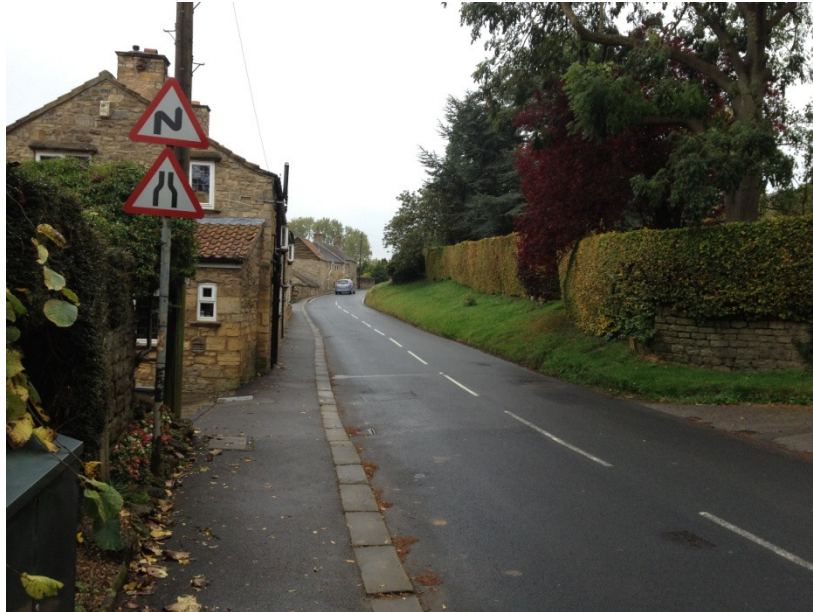
- 2.2.16 At its junction with Northgate Lane, Main Street does benefit from the provision of footways to both sides although the one on the west side is located on the top of an embankment for some distance before the carriageway alignment. The footways continue southwards along both sides as far as the junction with Trip Lane and then on the eastern side narrowing across the frontage to the Windmill Inn and then continuing south having a varying but narrow width (1m or less) before stopping outside a dwelling called The Barn.

Main Street looking south

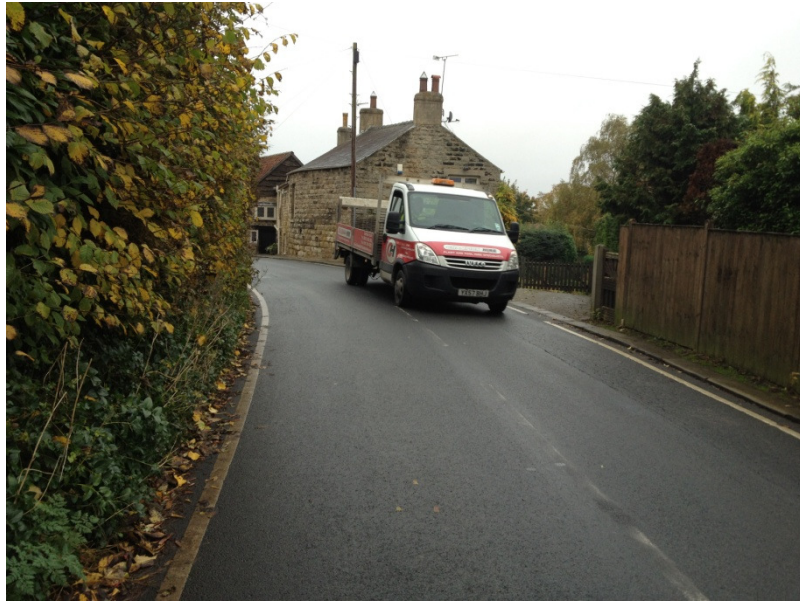
- 2.2.17 Main Street then narrows to 5.2m and rises over a slight hill which limits the forward visibility (to about 50m) and pedestrians have to walk in the carriageway. The narrow nature of the road at this point results in the rapid deterioration of the central road markings due to vehicle over running. This situation continues as Main Street bends and then drops down to Linton Bridge.

Main Street looking north at narrowing

5.1.4 As traffic volumes increase along Main Street the conditions created by the narrowing and poor forward visibility will become more difficult for drivers and more particularly, pedestrians and cyclists. In such circumstances a priority system controlled by traffic signals would allow the carriageway to be narrowed further to provide a footway over a greater length of Main Street (which may have to be limited in width at the narrowest section) and so improve road safety and reduce the potential for conflicts.

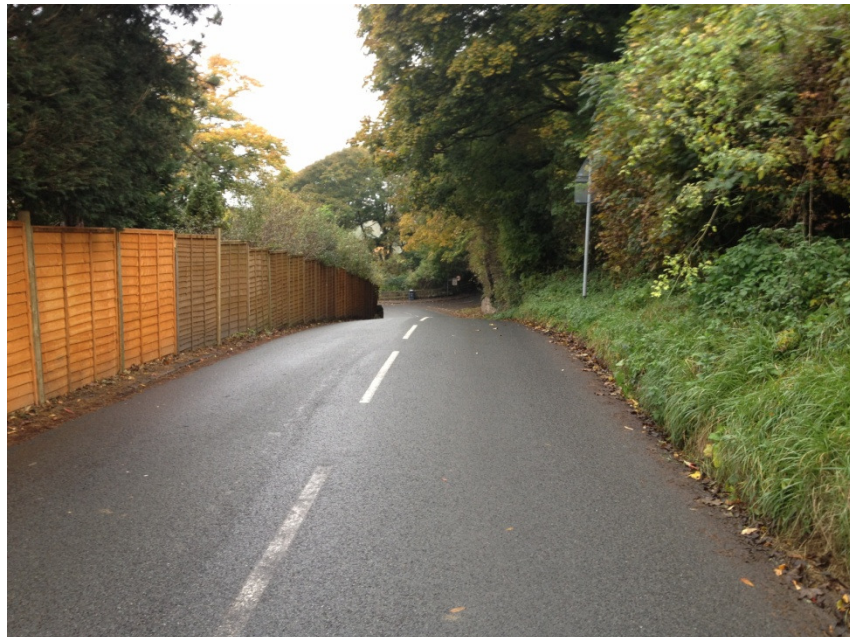
Main Street looking south at narrowing

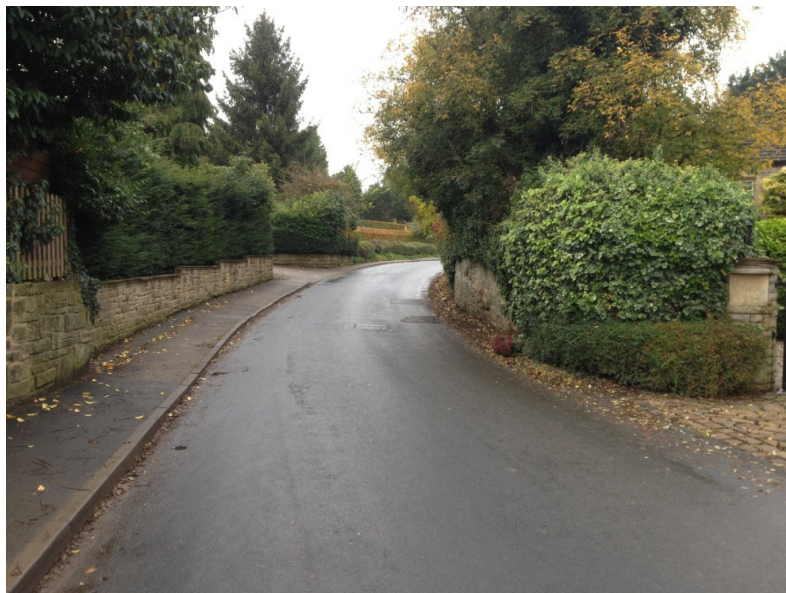
- 2.2.19 In addition to the carriageway width restriction in Northgate Lane close to its junction with Linton Lane there is a further restriction to the north of its junction with Northgate Rise / Muddy Lane to 4.8m. However forward visibility is good at this location. It then widens and continues in a northerly direction with dwellings to both sides then at the end of the 30 mph speed limit, development only occurs on the eastern side for further 280m before entering the open countryside.

Northgate Lane looking northwest at narrowing

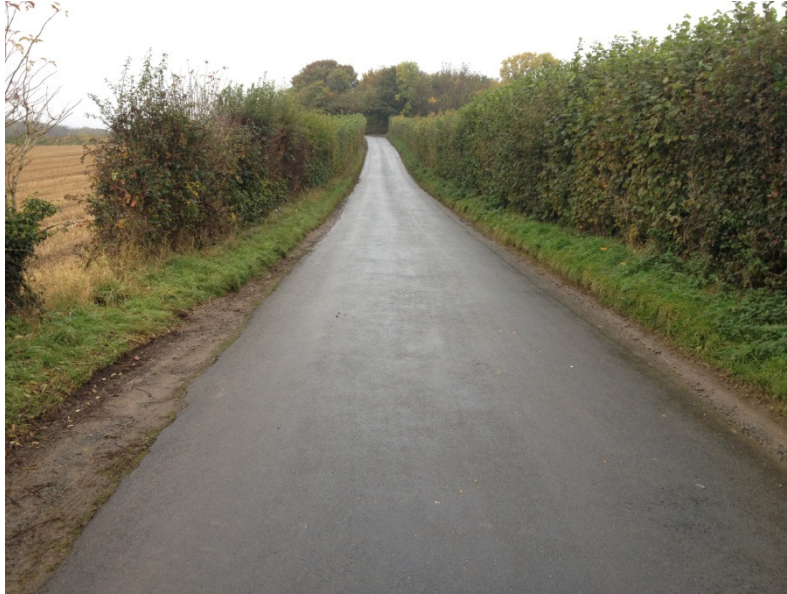
- 2.2.20 As Northgate Lane continues northwards its width varies with a number of narrow points and a long section just south of its junction with the Sicklinghall Road where the width (3.4 – 3.8m) results in significant verge over running / damage.

Northgate Lane looking north at narrow section

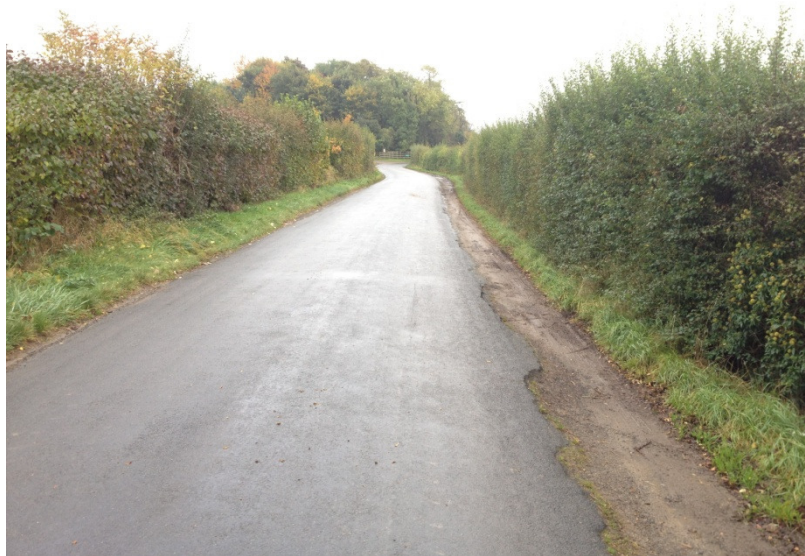
Northgate Lane looking south at narrow section

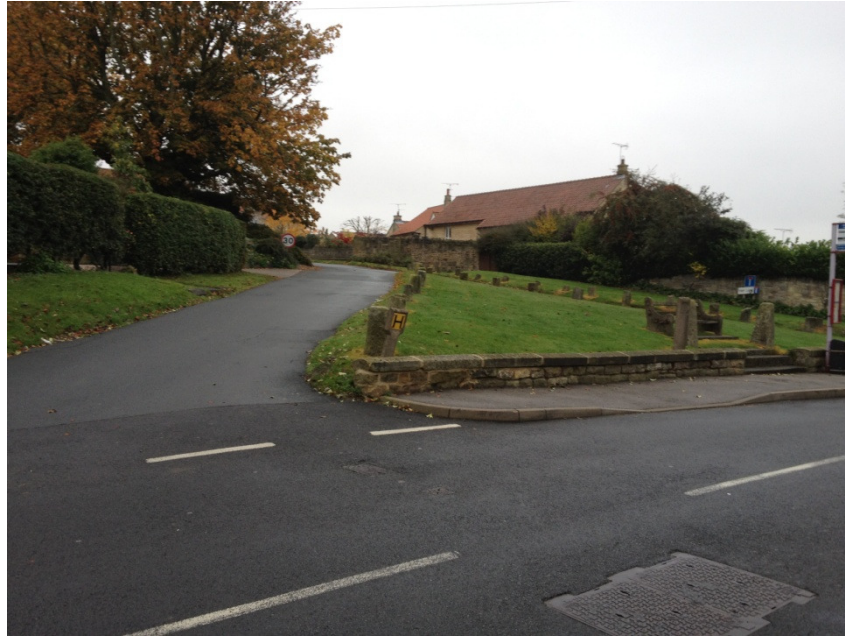
- 2.2.26 At the junction of Trip Lane with Main Street, the former road splits in to two narrow (3.7m) carriageways around a triangular grassed area. Whilst each carriageway is too narrow for passing vehicles, the presence of large stones in the adjacent verges discourages over running.

Trip Lane junction with Main Street

5.2.1 It is our view that any significant increase in the volume of traffic using Trip Lane would cause potential conflicts in the use of the informal one way system around the triangular grassed area at its junction with Main Street. Whilst there are other narrow sections along Trip Lane, the forward visibility is adequate to allow drivers to give and take in safety and so accords with the principles of Manual for Streets.

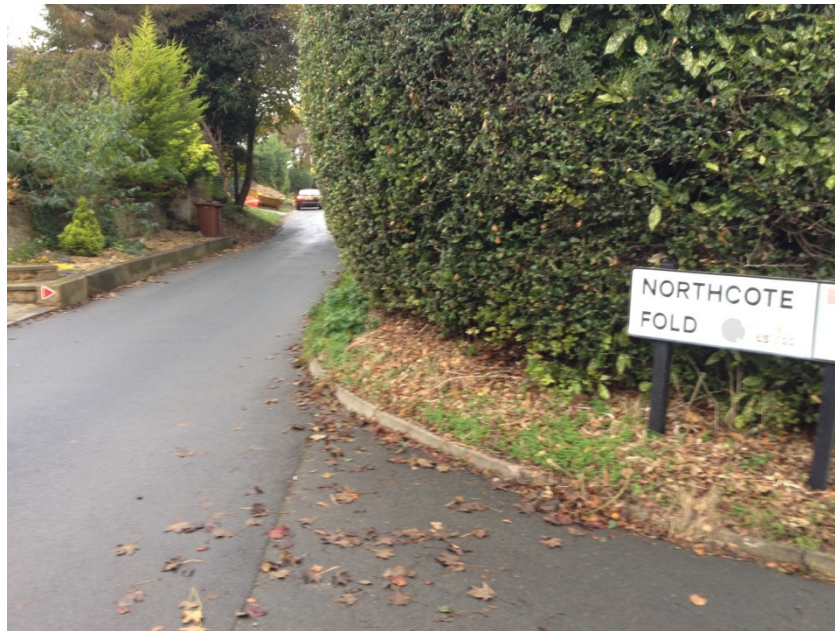
- 2.2.27 There is no indication whether vehicles should use this road layout in a one way fashion but local people were observed doing so. Visibility at the informal “exit” is good however should a vehicle use the “entry” to join Main Street then visibility to the right is only 17.6m.
- 2.2.28 Trip Lane is a narrow lane (typically 3.6 to 3.8m) with occasional widened sections (5.2m). There is a single speed reducing hump part way along its length which has been formed from tarmac.
- 2.2.29 There is a short narrow (1.1m) footway along the northern side up to its junction with Northcote Fold. The latter has almost no visibility to the right for vehicles joining Trip Lane.

Trip Lane looking west at Northcote Fold junction and narrowing

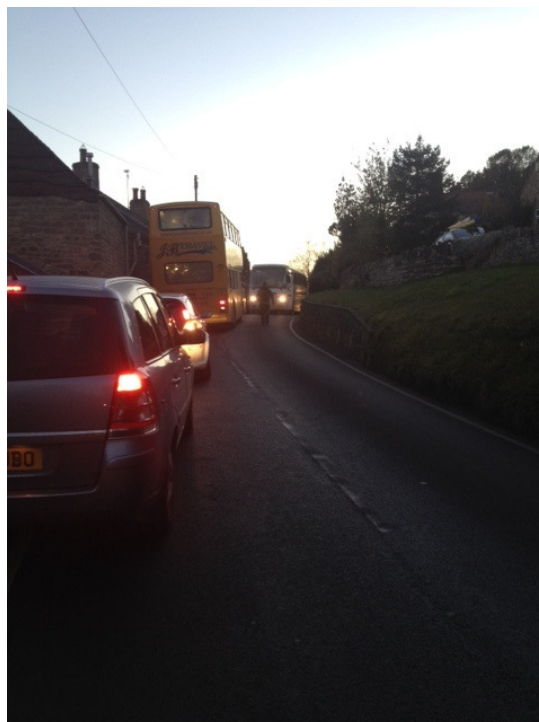
3.1.2 If the centre of the village is defined as being between the Windmill Inn and the community hall, the level of footway provision here is considered reasonable. However this is reduced and lost completely to the south and places pedestrians (particularly those who might walk to the local school) in conflict with traffic travelling along a narrower section with limited forward visibility. The photograph below shows a recent incident that occurred when two buses met each other on this narrow section.

Main Street looking north at narrow section

3.1.3 The width of the highway at this point (5.2m) is less than what would normally be looked for from a new road to cater for use by buses (6.0 to 6.75m). The presence of walls and fences close to the carriageway edge tends to push vehicles more towards the middle of the road.

5.1.2 A significant area of concern is the narrow nature of the road and poor alignment travelling to the south of the village together with the lack of footways for pedestrians. As traffic volumes increase then this situation will only deteriorate and become more intimidating for vulnerable road users such as pedestrians and cyclists.
